LYNDE BROOK RESERVOIR DAM

EAST DIKE

PHASE I INSPECTION REPORT
NATIONAL DAM INSPECTION PROGRAM

MAY 1980

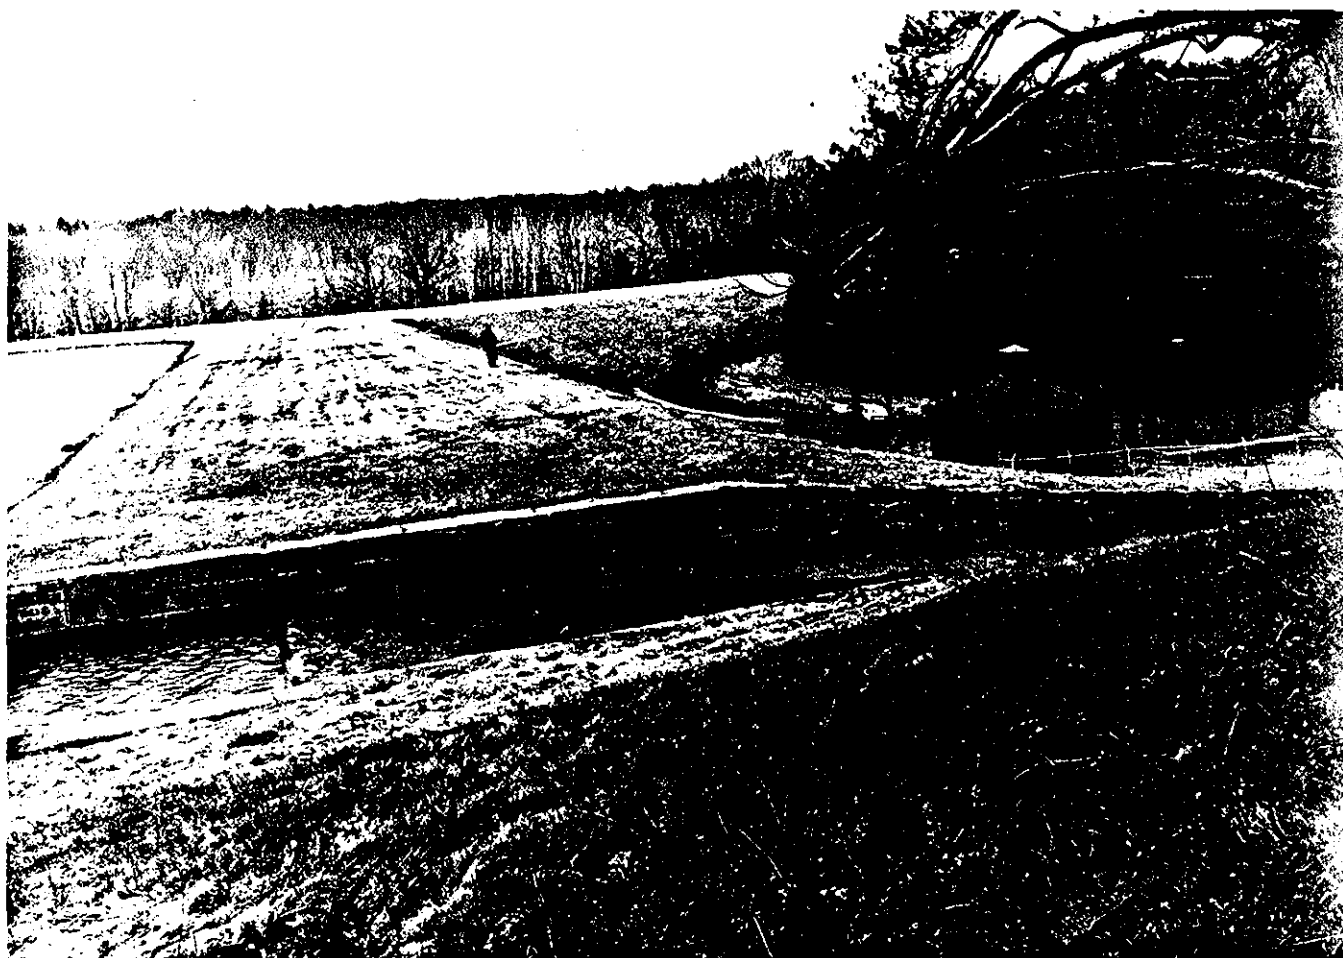
OVERVIEW OF DAM FROM RIGHT ABUTMENT

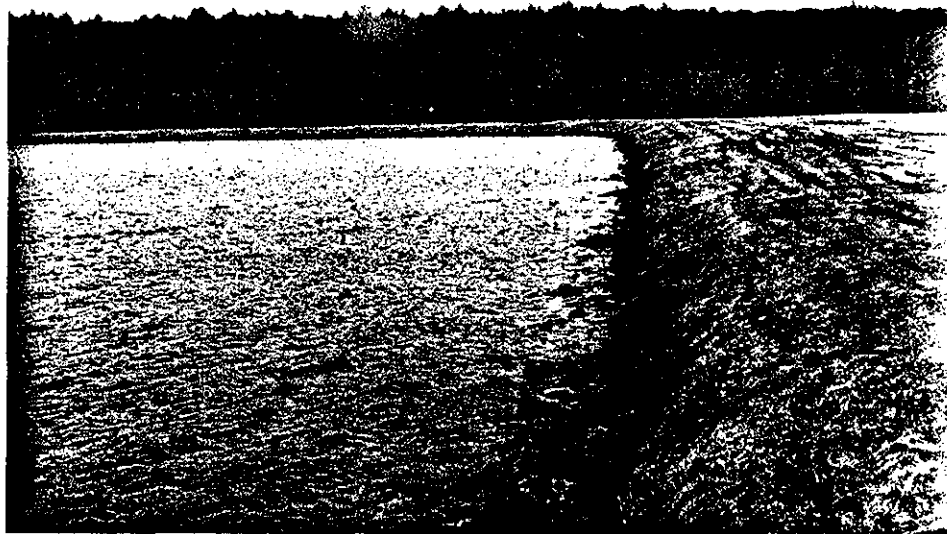
1. Upstream slope of dam

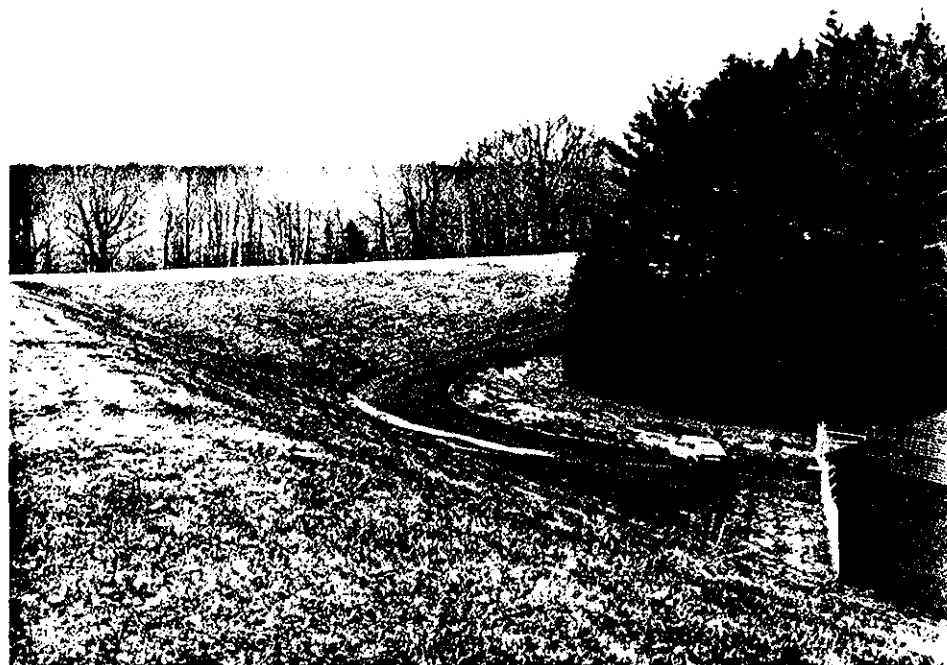
2. Downstream slope of dam

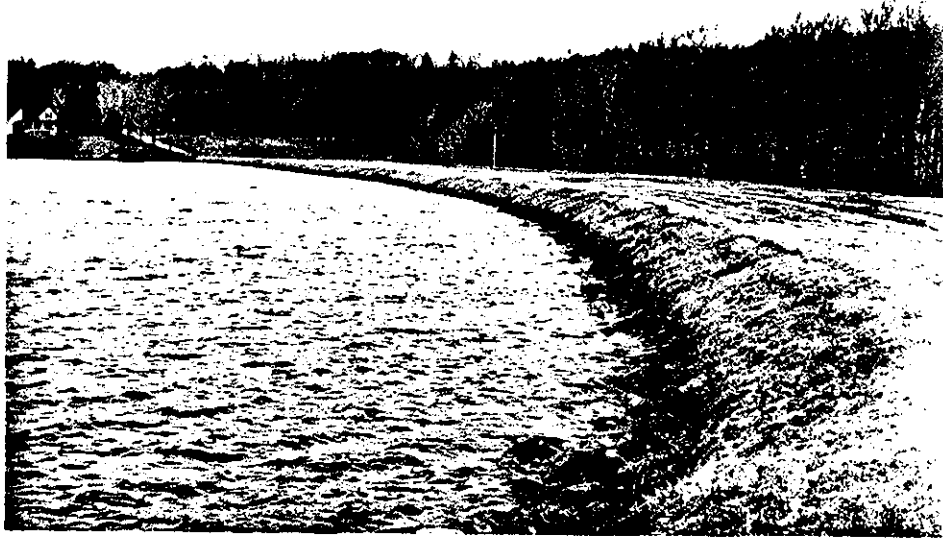
Dike. The dike is also an earth embankment with a masonry core wall. It is about 1,050 ft. long, 14.5 ft. high and has a crest width of about 42 ft. The crest and $1\frac{2}{3}$ horizontal to 1 vertical downstream slope are grass covered and well maintained. The upstream slope is of random rock riprap. At the time of the inspection there was no evidence of seepage along the dike. In general the dike is in excellent condition (see Appendix C, Photo Nos. 3 & 4).

3. Upstream slope of East Dike

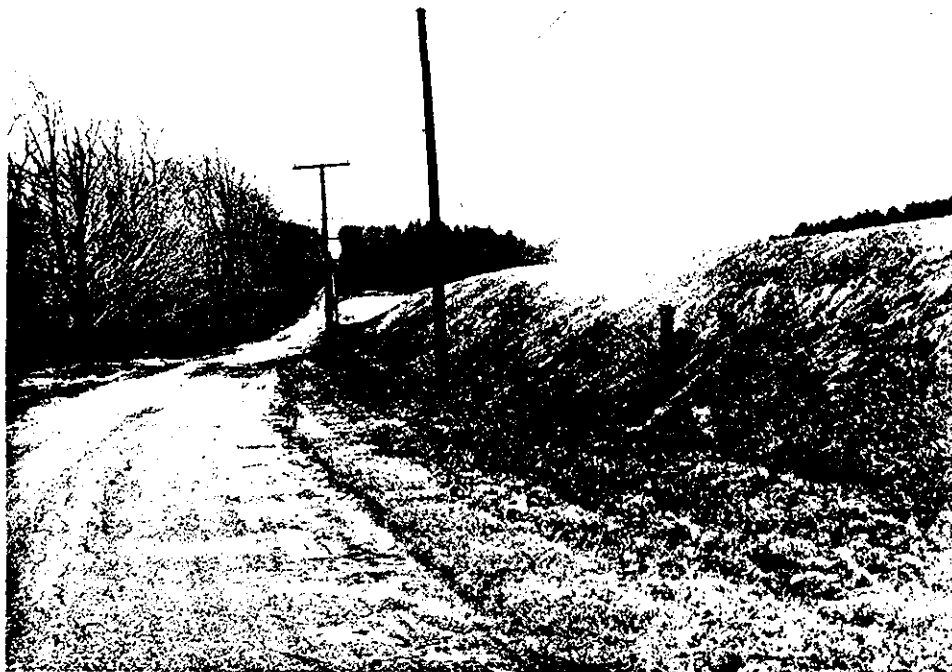
4. Downstream slope of East Dike

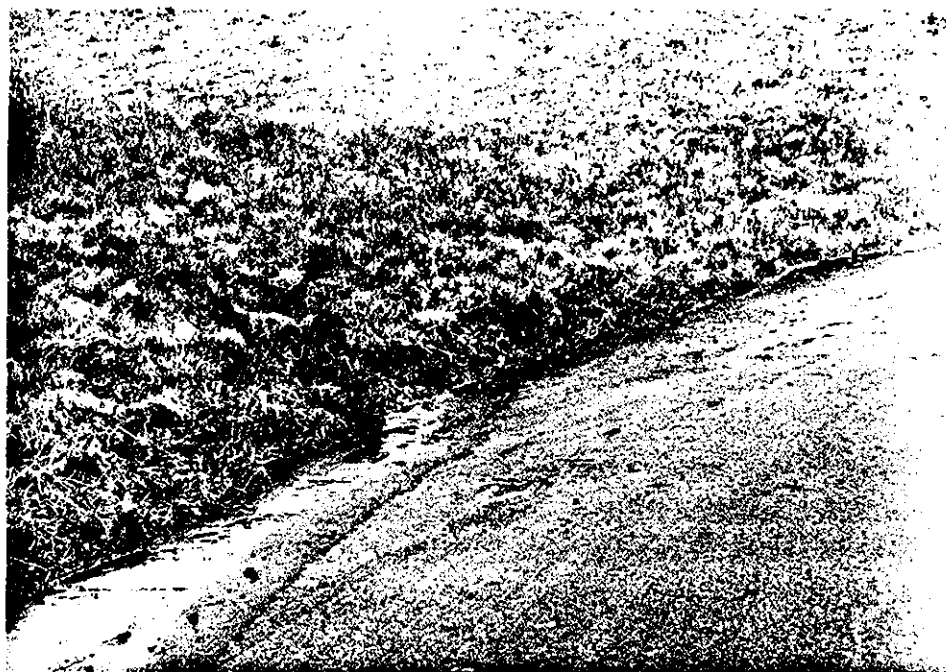
6. Seepage at junction of dam and left abutment of dam

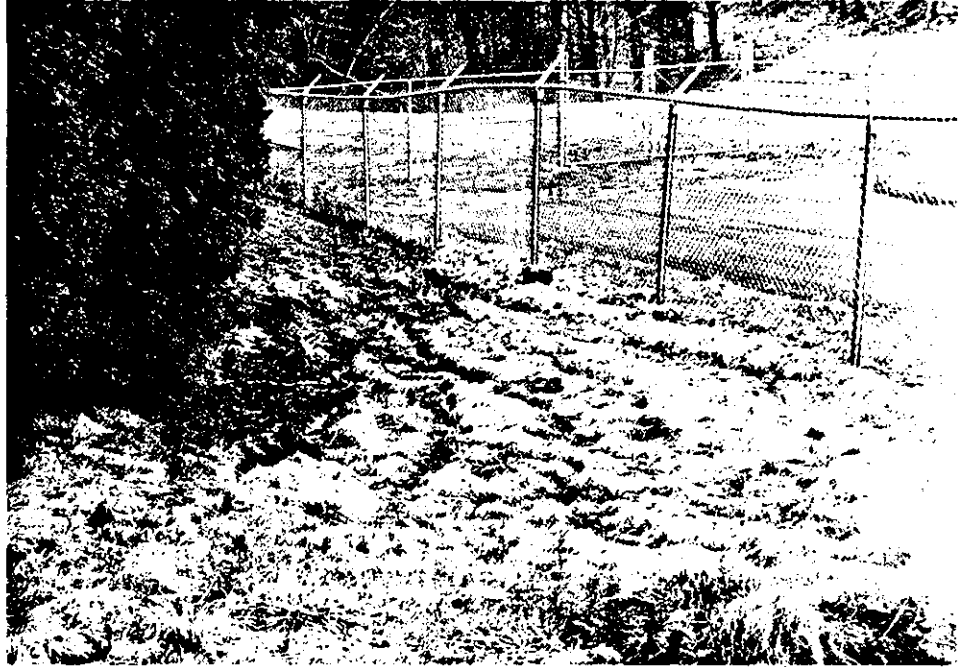
7. Seepage on south side of roadway along downstream toe of dam.

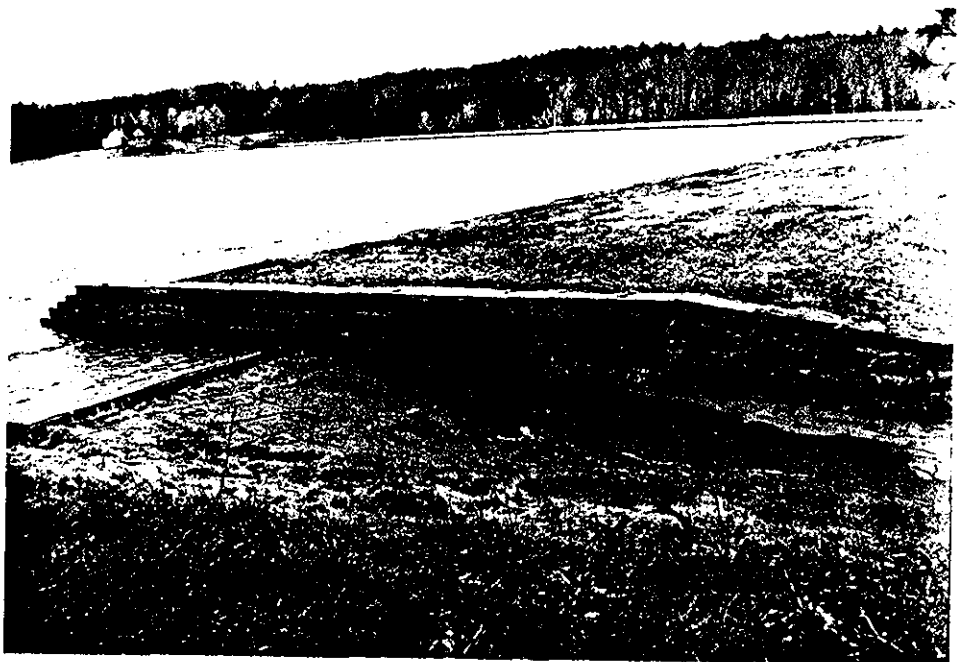
8. View of spillway crest from right abutment.

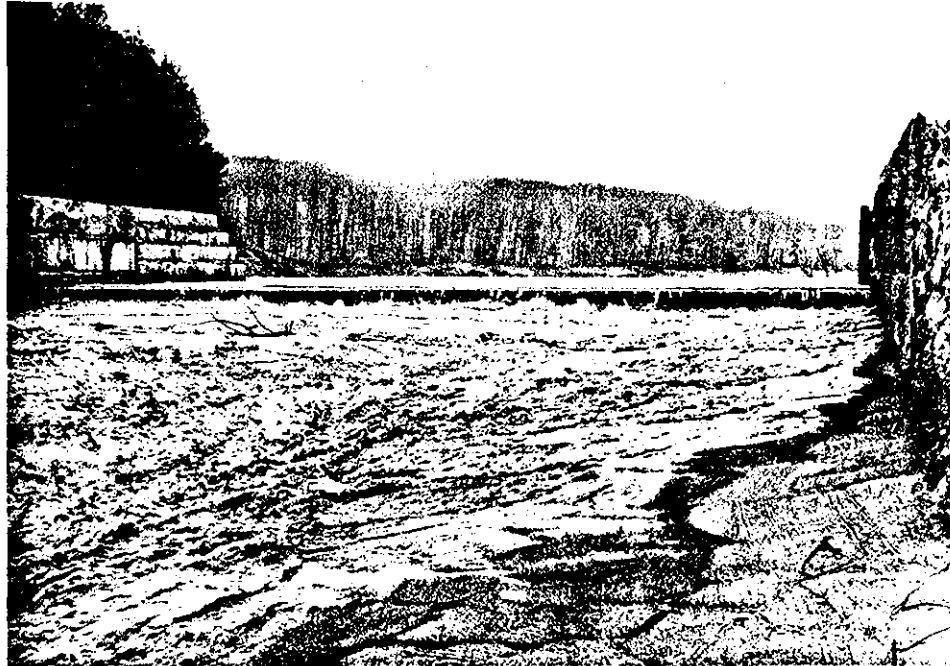
9. Spillway training walls and angle iron sill

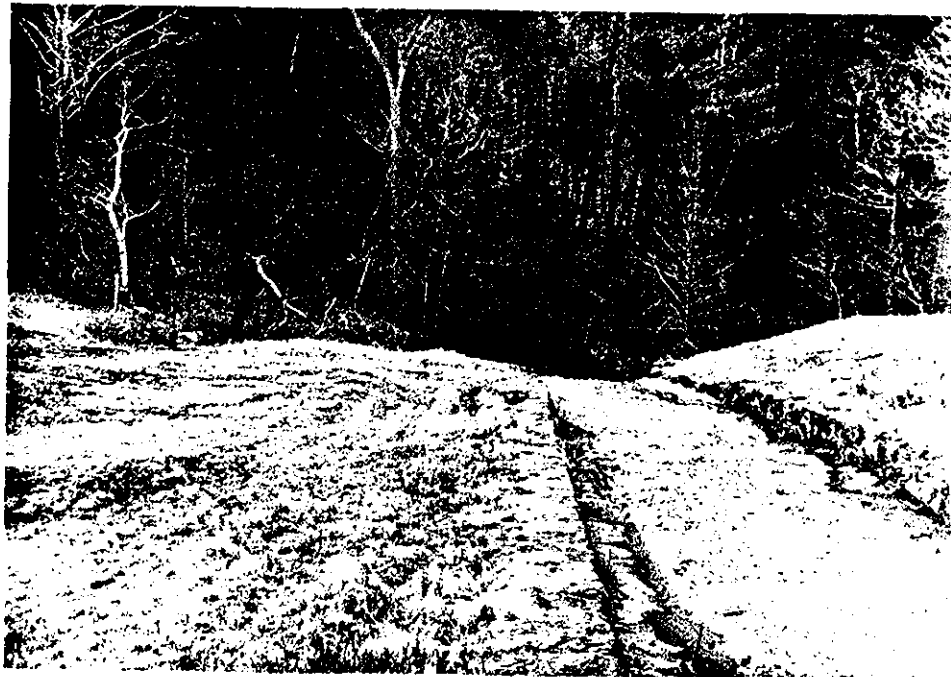
10. Downstream spillway channel

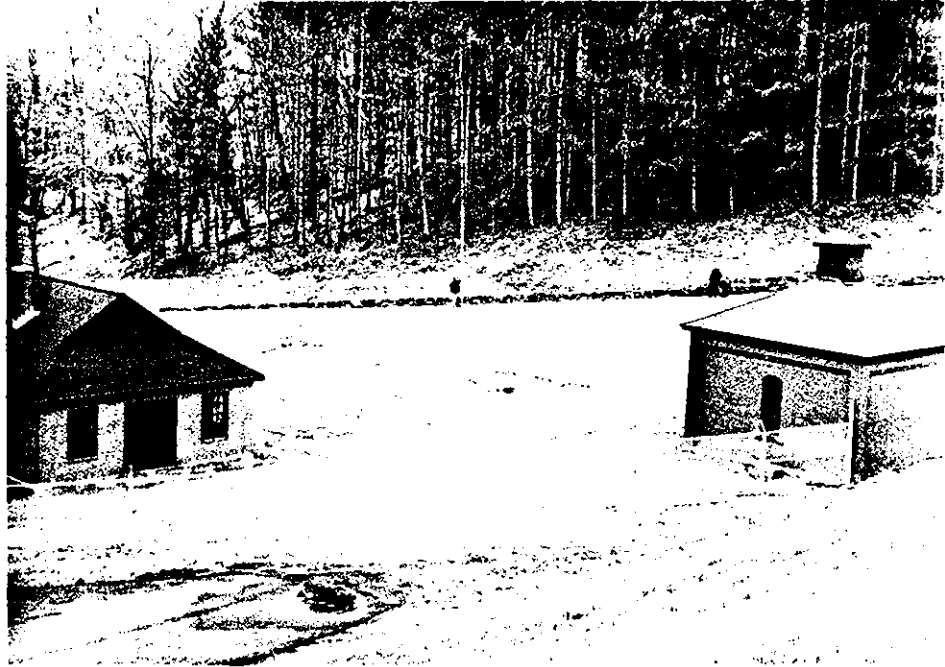
11. Outlet gate house on right and chlorination building on left at downstream toe of dam.

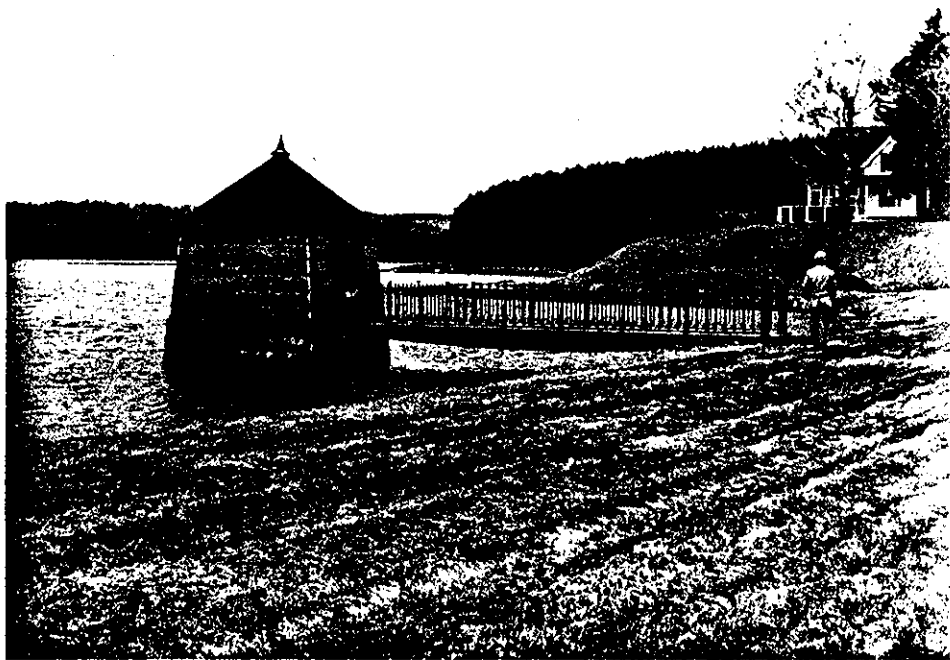
12. Gate house at northerly end of East Dike

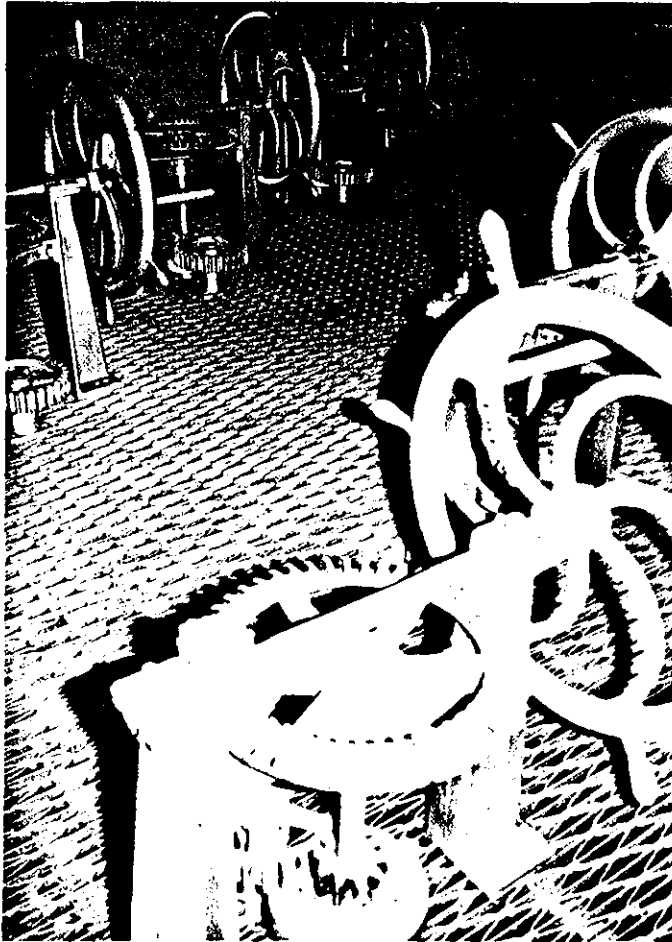
13. Manual operating mechanisms in first floor of gate house at downstream toe of dam.
